# A snapshot of water quality from sampling freshwater invertebrates in Purau stream, Lyttelton Harbour/Whakaraupō

Report for Environment Canterbury

Land Environment and People Research Report

No. 55

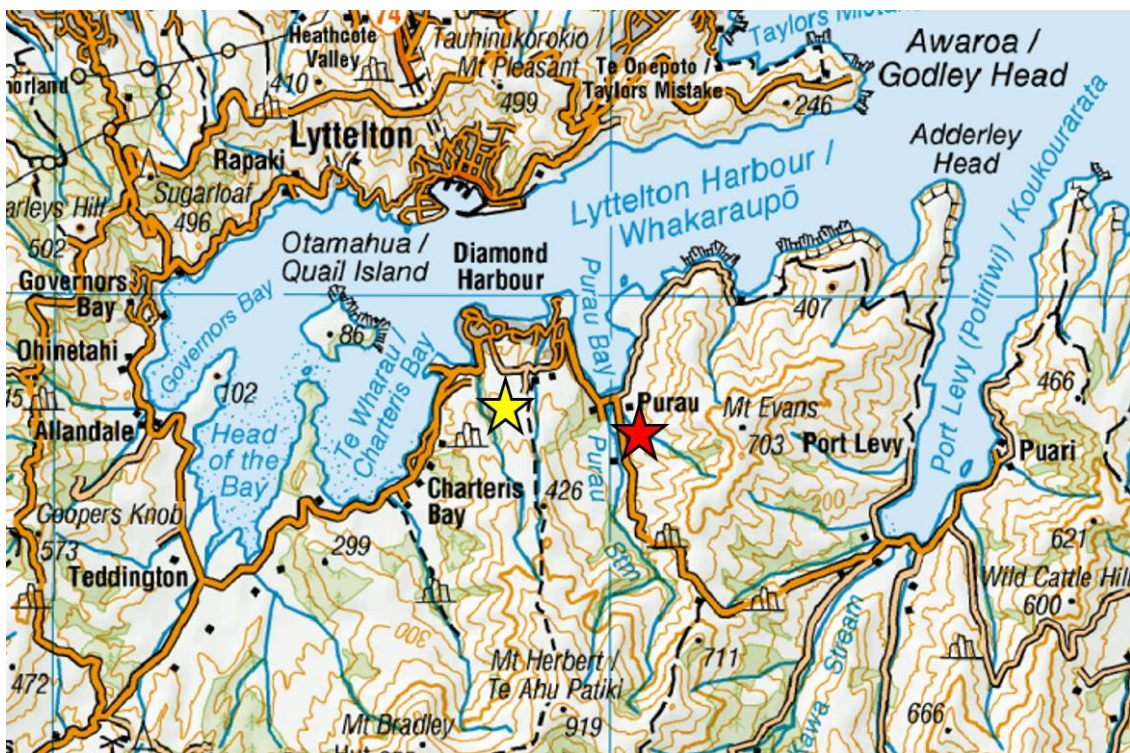
**Figure 1:** Location map of study sites in Purau (red star) and Te Wharau (yellow star) catchments.

Whaka-ora Healthy Harbour and Lincoln University jointly funded a summer research scholarship to investigate the environmental quality of Purau Stream in late 2020/early 2021. Results from sampling for aquatic invertebrates are reported here along with a discussion about the stream health. The results are compared with Te Wharau stream, which is a separate catchment to the south (Figure 1).

This study took place in Purau Bay and Orton Bradley Park (Figure 1). Sampling was conducted in the middle of January 2021 over two days. The temperature during this time was 13-14 °C with between 0.5 mm and 1.0 mm of precipitation in the 2 days leading up to the sampling, recorded at nearby Cooper's Knob.

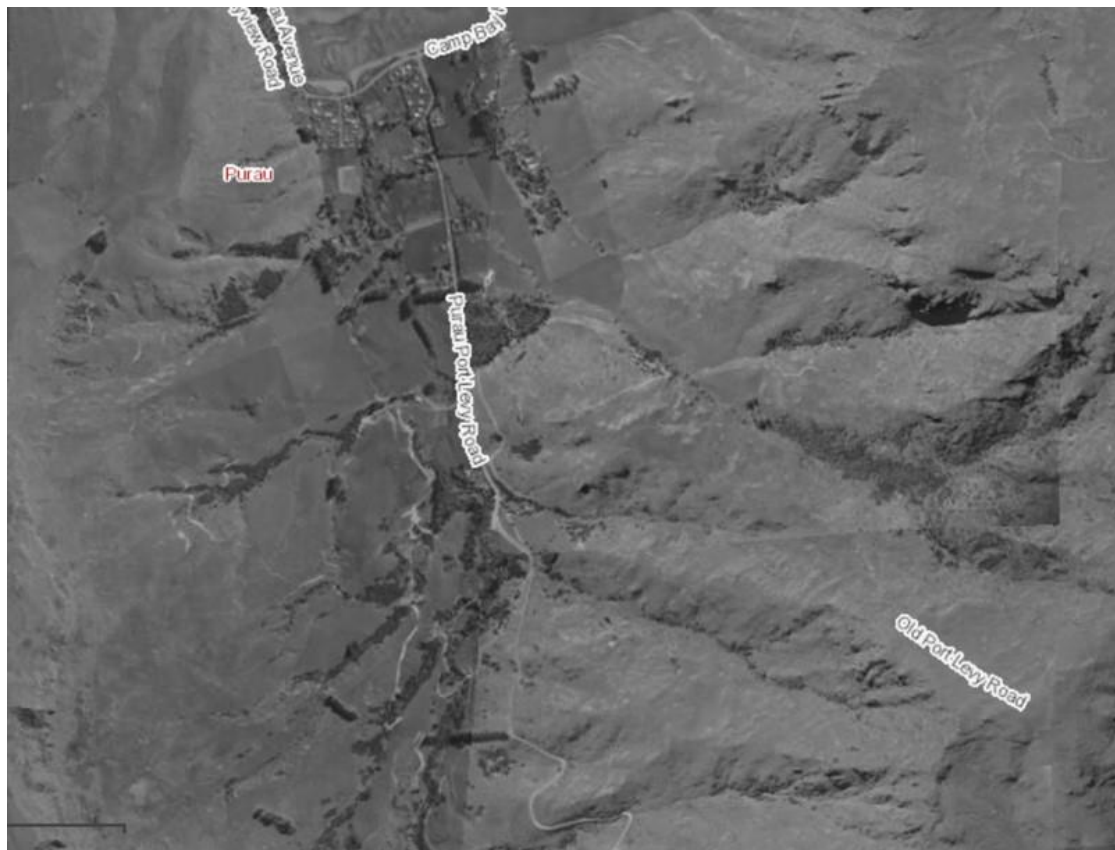
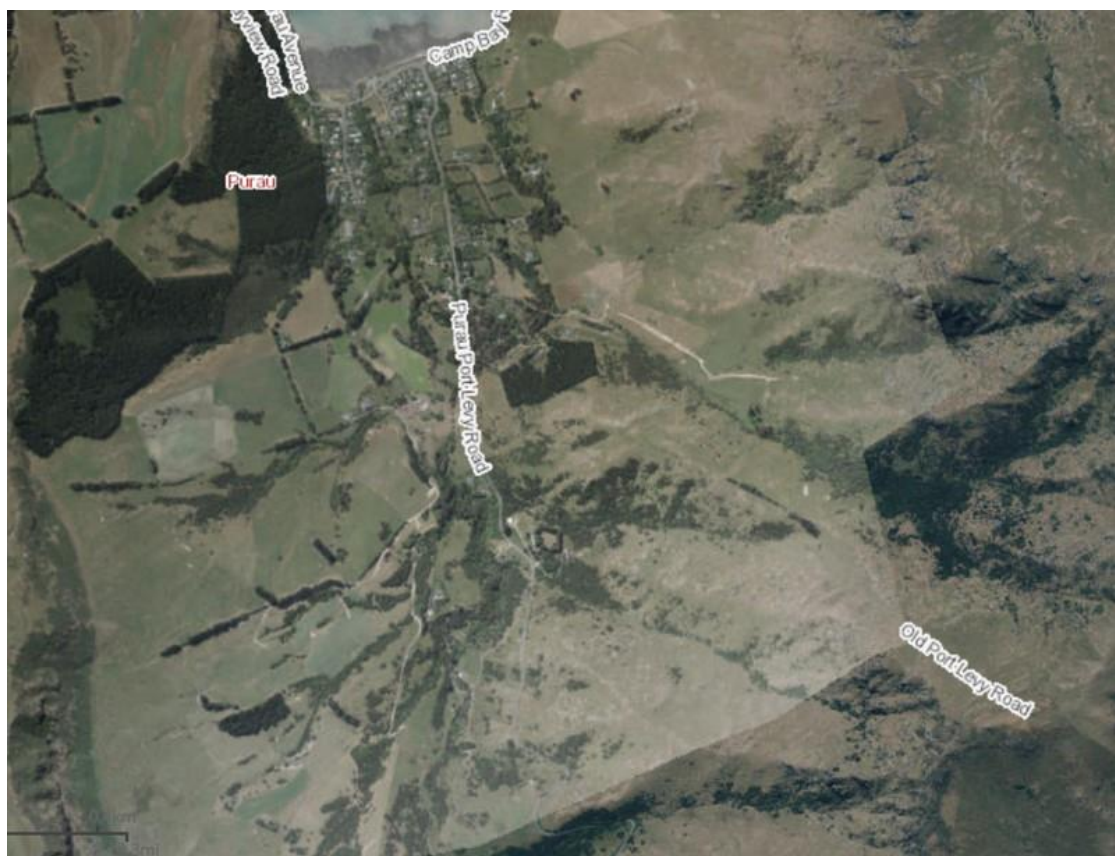
**Figure 3:** (Top) Aerial imagery of Purau catchment vegetation 1970-1974. (Bottom) 2018 imagery retrieved 19 February 2021 <https://apps.canterburymaps.govt.nz/CanterburyHistoricAerialImagery/>

Aerial imagery shows that scrub and tree cover is greater in recent times than the early 1970s (Figure 3). This due to the retirement of some marginal areas, riparian areas being fenced off, restoration plantings of indigenous species, and radiata pine (*Pinus radiata*) production forestry. The Purau catchment is now used primarily for grazing sheep and cattle, pine forestry, with a small settlement.

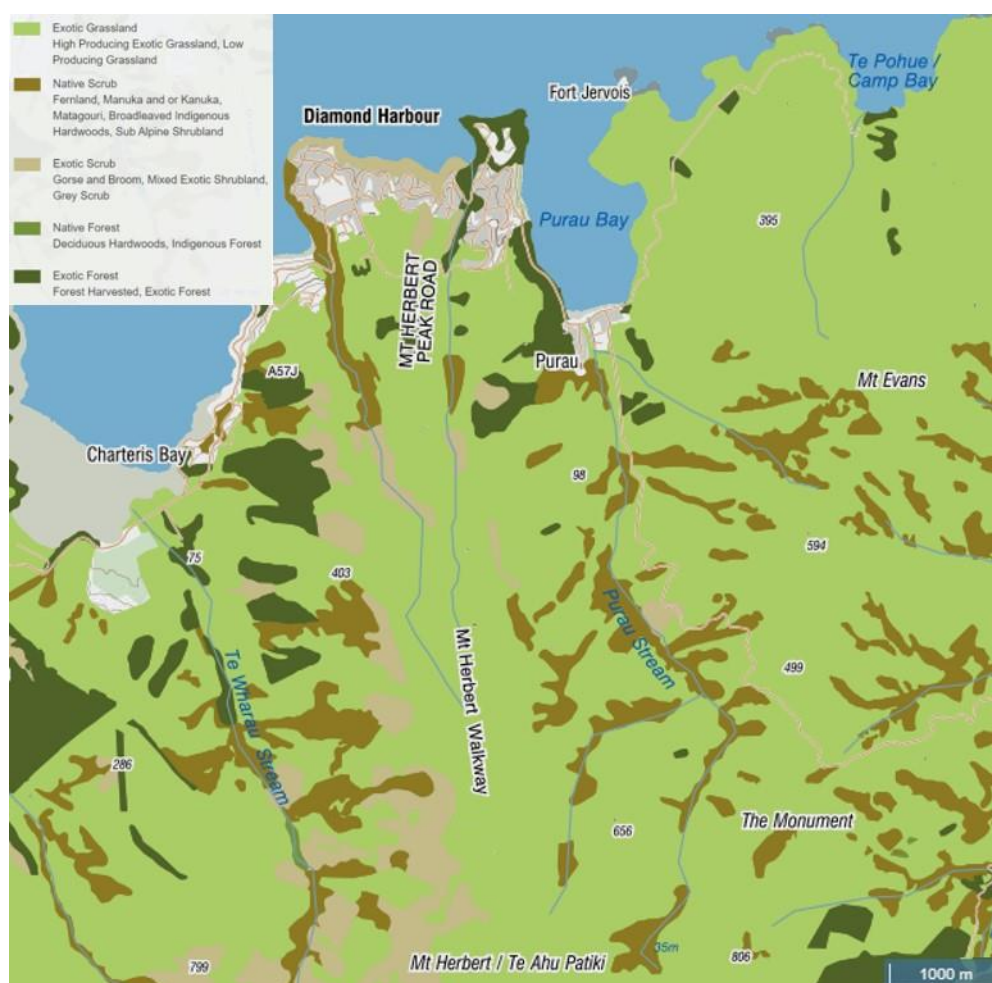
**Figure 7:** Current vegetation patterns in Purau and Te Wharau catchments. Source: Manaaki Whenua Landcare Research's *Our Environment*.

The streams selected for this study were Purau stream (-43.639154 S, 172.750120 E) located in Purau Bay, and Te Wharau Stream (-43.654954 S, 172.705582 E), located in Orton Bradley Park, Charteris Bay (Figure 6). Both catchments have pastoral agriculture, primarily grazing for sheep and cattle in the upper and middle areas of the catchment (Figure 7). The lower catchment areas differ with Purau predominantly urban, immediately surrounding the stream. Orton Bradley is a privately owned park which has public facilities and walking tracks in the lower catchment area. Both catchments have areas of exotic tree species, including areas of radiata pine plantations, willows along streamsides, and regenerating native shrub and tree species (Figure 7).

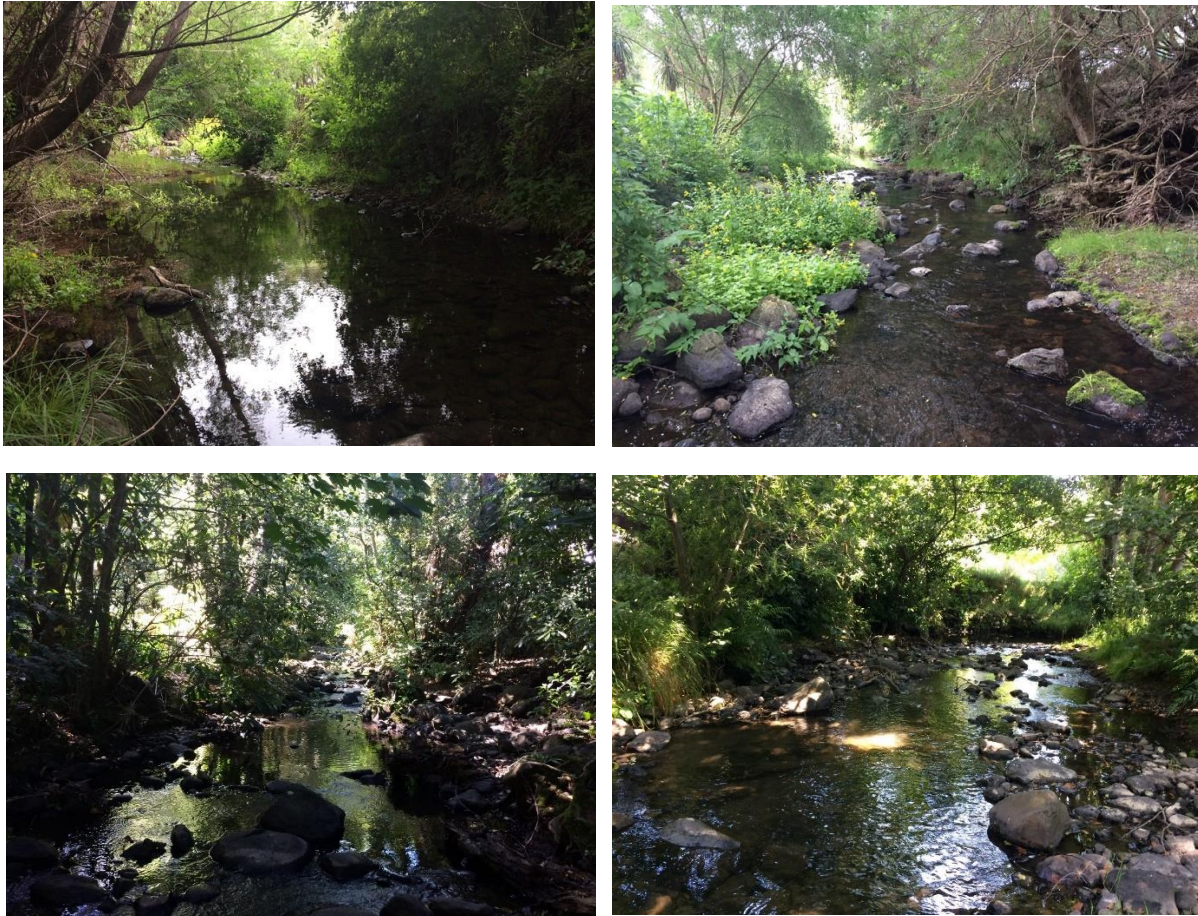
**Figure 8:** (*Top left*) Purau Stream Site 1 (Bridge) looking upstream. (*Top right*) Purau Stream Site 2 looking downstream. (*Bottom left*) Te Wharau Stream Site 3 looking upstream. (*Top right*) Te Wharau Stream Site 4 looking downstream.

The results from the qualitative assessment of canopy cover (Figure 13) also did not suggest differences in assessed cover were an explanatory factor in the MCI patterns observed. Purau Site 1 and Te Wharau Site 4 (Orton Bradley Site 2) had similar cover at >60%, yet the MCI scores differed markedly (Figure 10). The MCI scores of Purau Site 2 and Te Wharau Site 3 (Orton Bradley Site 1) were similar to Te Wharau Site 4, yet canopy cover for Purau Site 2 was much lower at 40% (Figure 13). The site photos show all sites had shading from intact tree cover (Figure 8).
